DELTA CONTROLS CORPORATION
SHREVEPORT ENGINEERING

STANDARD PURGED WINDOW

DELTA HEATED WINDOW

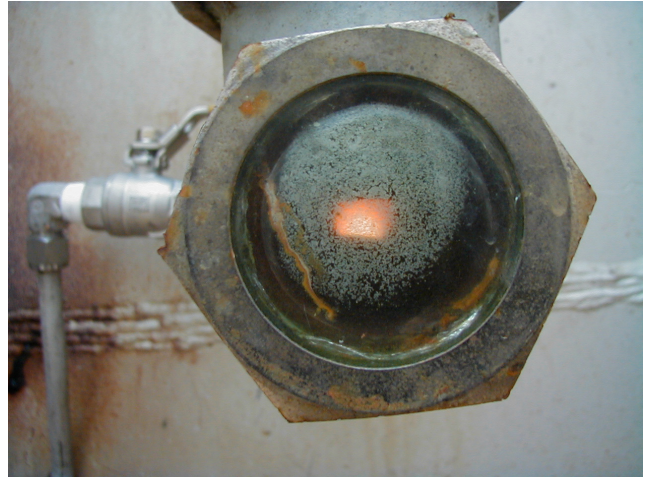
Looking through a cool viewing window into an operating Claus Thermal Reactor. Note that sulfur has precipitated onto the viewing window in spite of the air purge. The sulfur particles block infrared radiation.

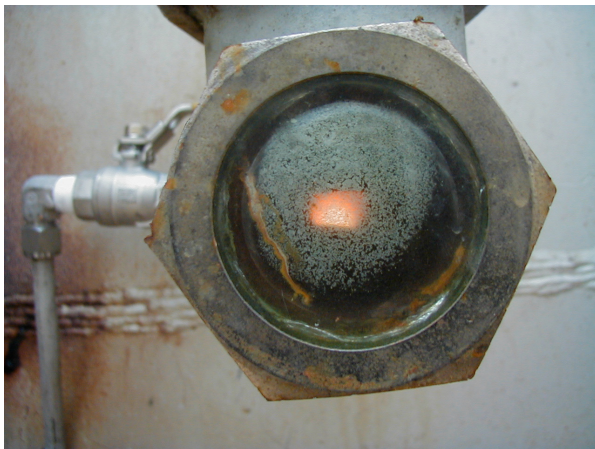
INCREASE OF COOL WINDOW BUILDUP OVER TIME

Photo Of A Cool Window After 6 Months Of Operation

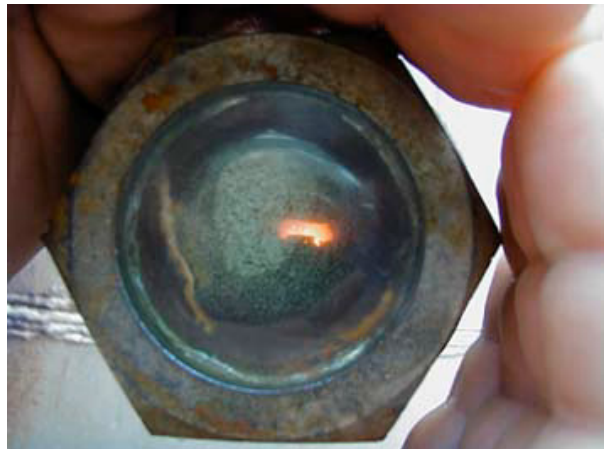
Photo Of The Same Window After 12 Months Of Operation
